Town of Erin Final Report

October 3, 2018

Downtown Erin Main Street – Streetscape Dual Stream (Waste & Recycling)

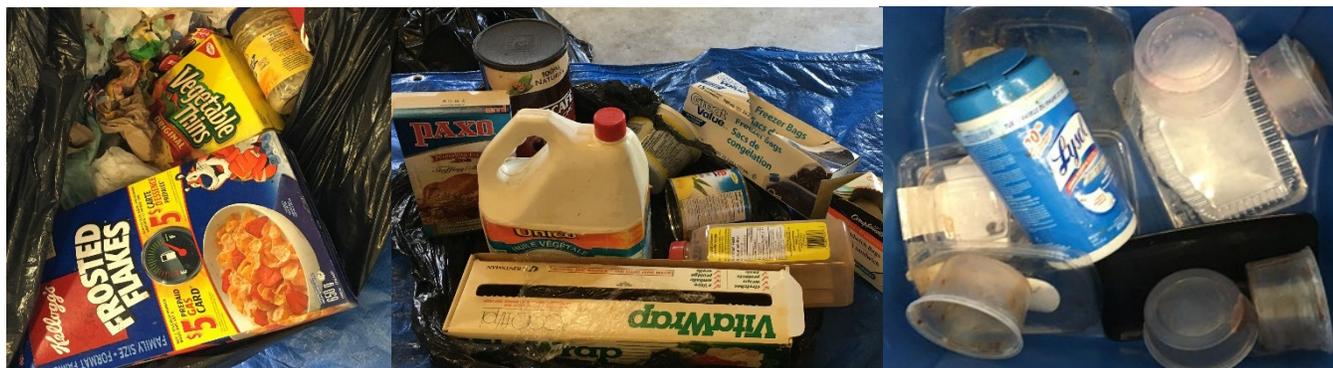
Assessment results – Main Street Streetscapes

- Increase in beverage container recovery from 74% in the pre audits to 87% in the post audits
- Reduction in contamination from 57% to 40%
- Ensure all “no coffee cup” decals are placed on bins to further reduce coffee cups entering the recycling stream as contamination
- Ensure contractor is using correct bags when servicing Main Street bins
- Some streetscape bins along Main Street are being used by tenants that live on the second story above the businesses for household waste, using locks on these specific bins may help deter household waste from entering the streams.

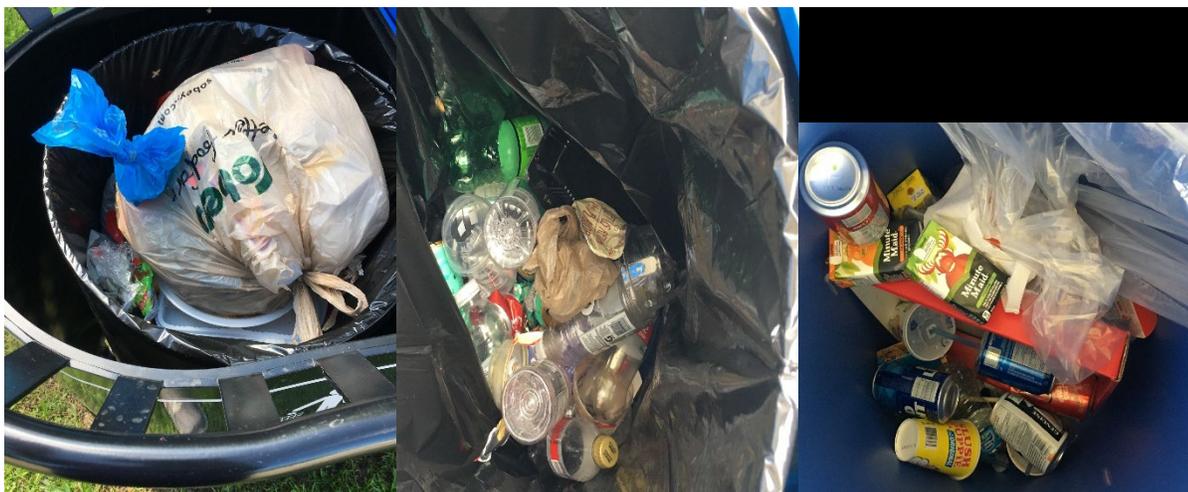
Assessment results – McMillan Park (parks and trails)

- Increase in beverage container recovery from 78% in the pre audits to 100% in the post audits
- Reduction in contamination from 67% to 45%
- Ensure all “no coffee cup” decals are placed on bins to further reduce coffee cups entering the recycling stream as contamination.
- Ensure contractor is using correct bags when servicing McMillan Park bins.

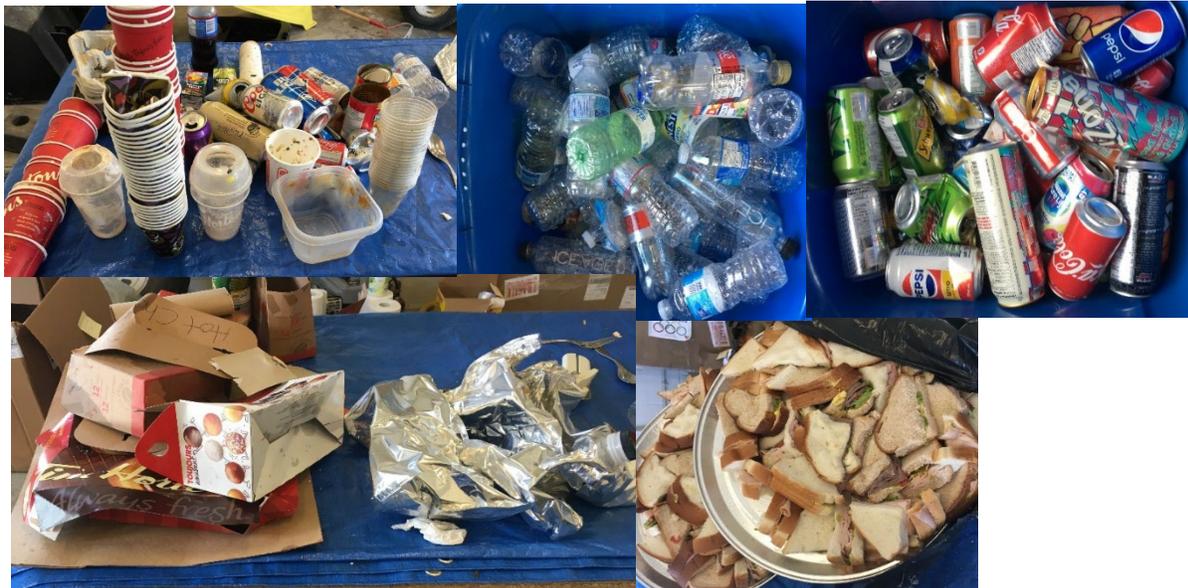
Assessment results – Centre 2000 (Indoor & Outdoor spaces)

- Increase in beverage container recovery from 27% in the pre audits to 88% in the post audits
- Reduction in contamination from 53% to 27%
- Ensure all “no coffee cup” decals are placed on bins to further reduce coffee cups entering the recycling stream as contamination.
- Ensure correct bags are used when servicing Centre 2000 bins
- Place remaining recycling bins outside remaining areas surrounding Centre 2000 (library entrance, tennis courts, gardens, soccer fields.)
