Town of Erin Final Report

October 3, 2018

Downtown Erin Main Street – Streetscape Dual Stream (Waste & Recycling)

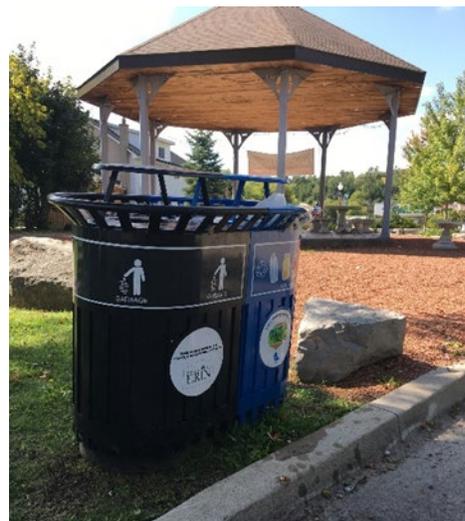
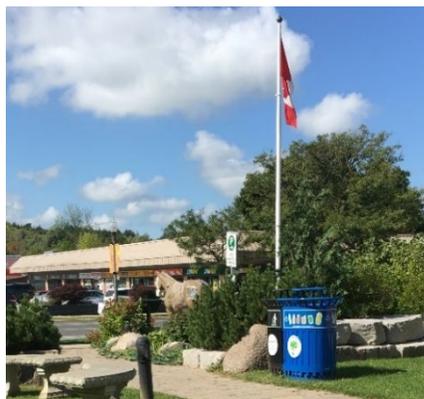
While not a large amount of material was generated at McMillan Park, the beverage container recovery rate found at the park was 100% with the majority of the recyclable material being beverage containers.

The contamination rate within McMillan Park also saw a decrease from 67% to 45% with the majority of the contamination polystyrene packaging and organic materials (liquid). No coffee cups were found in the recycling.

- Increase in beverage container recovery from 78% in the pre audits to 100% in the post audits
- Reduction in contamination from 67% to 45%
- Ensure all “no coffee cup” decals are placed on bins to further reduce coffee cups entering the recycling stream as contamination.
- Ensure contractor is using correct bags when servicing McMillan Park bins.

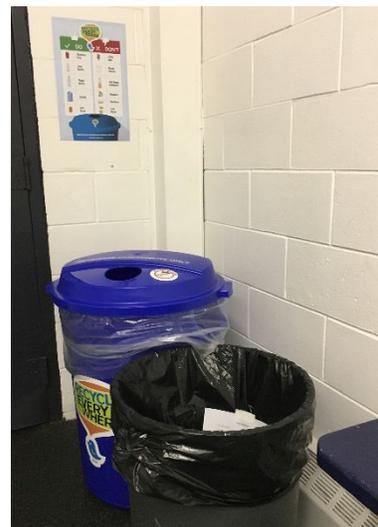
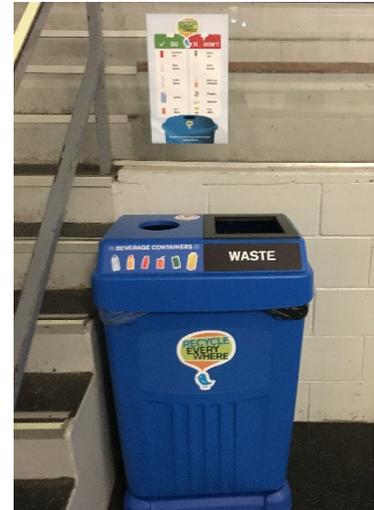
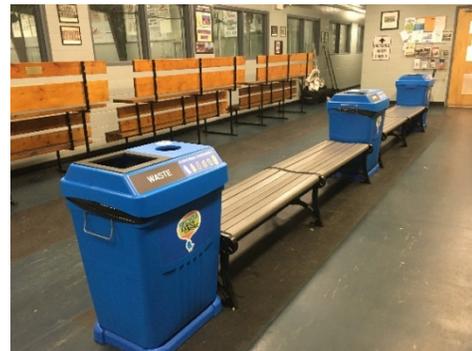
The material collected from the Centre 2000 included the indoor ice rink (dressing rooms and stands), hallways, front entrance, lobby, outdoor skate-park, and baseball diamonds. Approximately 78 kg of material was generated over the 5 day period with 28% of the material generated recyclable (10% beverage containers 18% other recycling). A significant amount of organic material (34%) was found in the garbage stream that included multi trays of uneaten sandwiches and other food products. The Centre 2000 may benefit from an organics program or look to donate leftover food to local organizations.

The contamination rate in the Centre 2000 decreased from 53% to 27% with the majority of the contamination caused by liquids and polystyrene packaging such as wrappers and film. The no coffee cup decals have greatly impacted contamination in a positive way, the volume of coffee cups found in the recycling was substantially less at 3% compared to 11% found in the pre audits. The replacement of infrastructure in to the indoor dual garbage and recycling bins has also positively impacted contamination and recovery rates with all of the bins now paired throughout the Centre 2000. The overall beverage container recovery rate increased very significantly from 27% to 88%.

- Increase in beverage container recovery from 27% in the pre audits to 88% in the post audits
- Reduction in contamination from 53% to 27%
- Ensure all “no coffee cup” decals are placed on bins to further reduce coffee cups entering the recycling stream as contamination.
- Ensure correct bags are used when servicing Centre 2000 bins
- Place remaining recycling bins outside remaining areas surrounding Centre 2000 (library entrance, tennis courts, gardens, soccer fields.)
